TECHNICAL BULLETIN INDEX
Sorted by Bulletin Number
06/25/86

DATE: May 12, 1982
REVISION DATE: May 13, 1983
BULLETIN NO: 16:1
PRODUCT: 26-6001/2 Model 16
SUBASSEMBLY: AX-9241 FDC Board (Redesign)

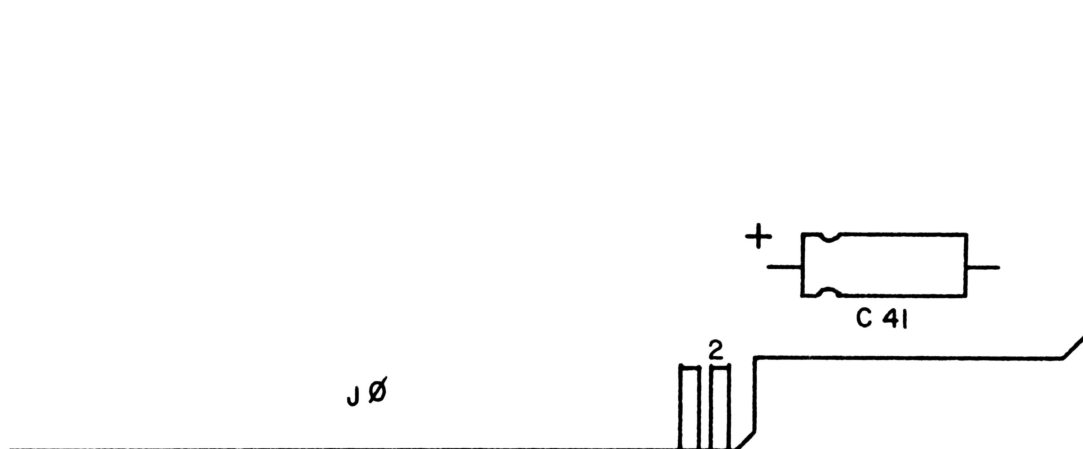
FIG 1

PURPOSE: To correct problem of C41 being installed backwards on early revision D Z-80 CPU boards.

DISCUSSION: On early Rev D boards C41 was installed backwards. This board and earlier revisions have had the (+) sign silk screened onto the board at the wrong end of the cap. The heavy trace attached to the capacitor on the component side of the PCB is ground and the positive lead of the cap should go to the other hole on the PCB.

PROCEDURE: Check all computers that are brought into the shop for this capacitor. If it is reversed, replace it with a new 33 mfd. cap with a voltage rating between 16 and 50 volts (Refer to Figure 1 for correct installation).

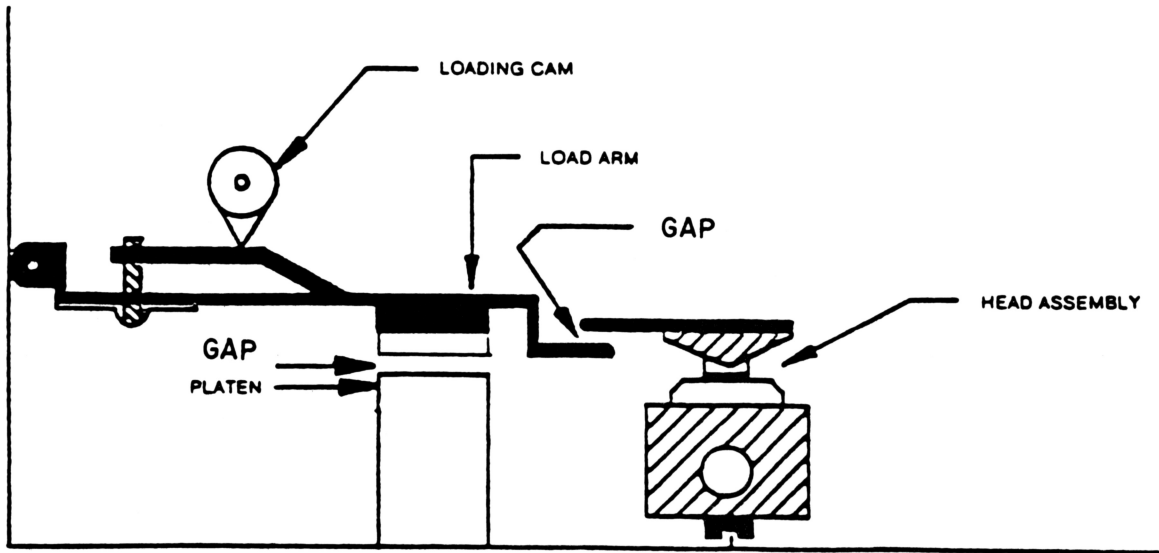
FIG 1

DISCUSSION: On some thinline drives the foam pad under the head load arm has been misadjusted so that the foam pad applies too much pressure to the diskette not allowing it to turn as it should. This problem can be solved by adjusting the head load arm. Also, on some drives the disk ejector has been pressing against the arm that presses the cone into the diskette. When this happens the diskette is not held as tightly as it should be. To correct this problem the trigger for the disk ejector can be adjusted.

HEAD LOAD ARM ADJUSTMENT

The head load arm should be adjusted so that there is about a .015-.030 inch gap between the foam pad and the platen (Refer to Figure 1) with the door closed and no diskette installed. Once this has been adjusted there should be a visible gap between the foam pad and the platen with the door closed and no diskette installed. Check that the upper head does not rub against the head load arm with a diskette installed and that the upper head does not hit the diskette when the diskette is being inserted or removed.

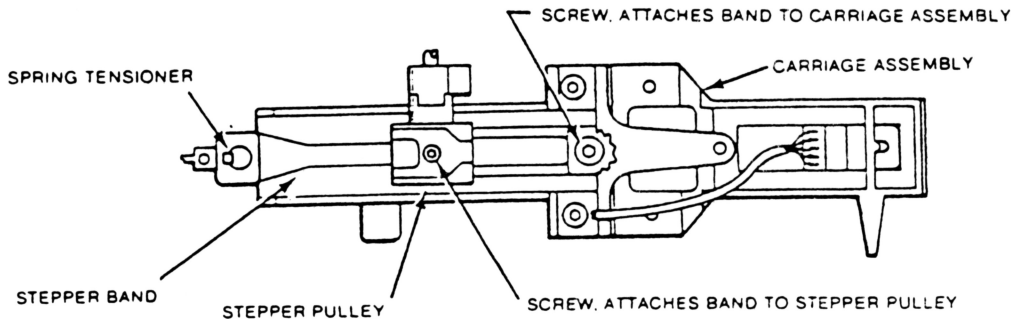
DISCUSSION: Early production models of the Tandon 8 inch slimline drive may have a problem with the stepper band assembly. The screw used to fasten the band to the stepper motor may allow slippage of the band assembly, therefore changing the head radial alignment. There should be only several hundred early production drives which have this problem. All recently manufactured drives will be using the new screw and washer to secure the stepper band assembly. The part numbers for these parts are AHD-2568 (screw) and AHD-8763 (washer) and they are now available at National Parts using catalog number 26-4167.

PROCEDURE: Install the longer screw and the larger washer in the place of the old screw. The larger washer applies more contact to the stepper band and the longer screw is needed due to the increased thickness of the washer. After replacement it is essential that you perform a drive alignment to verify that the drive meets Radio Shack specifications.

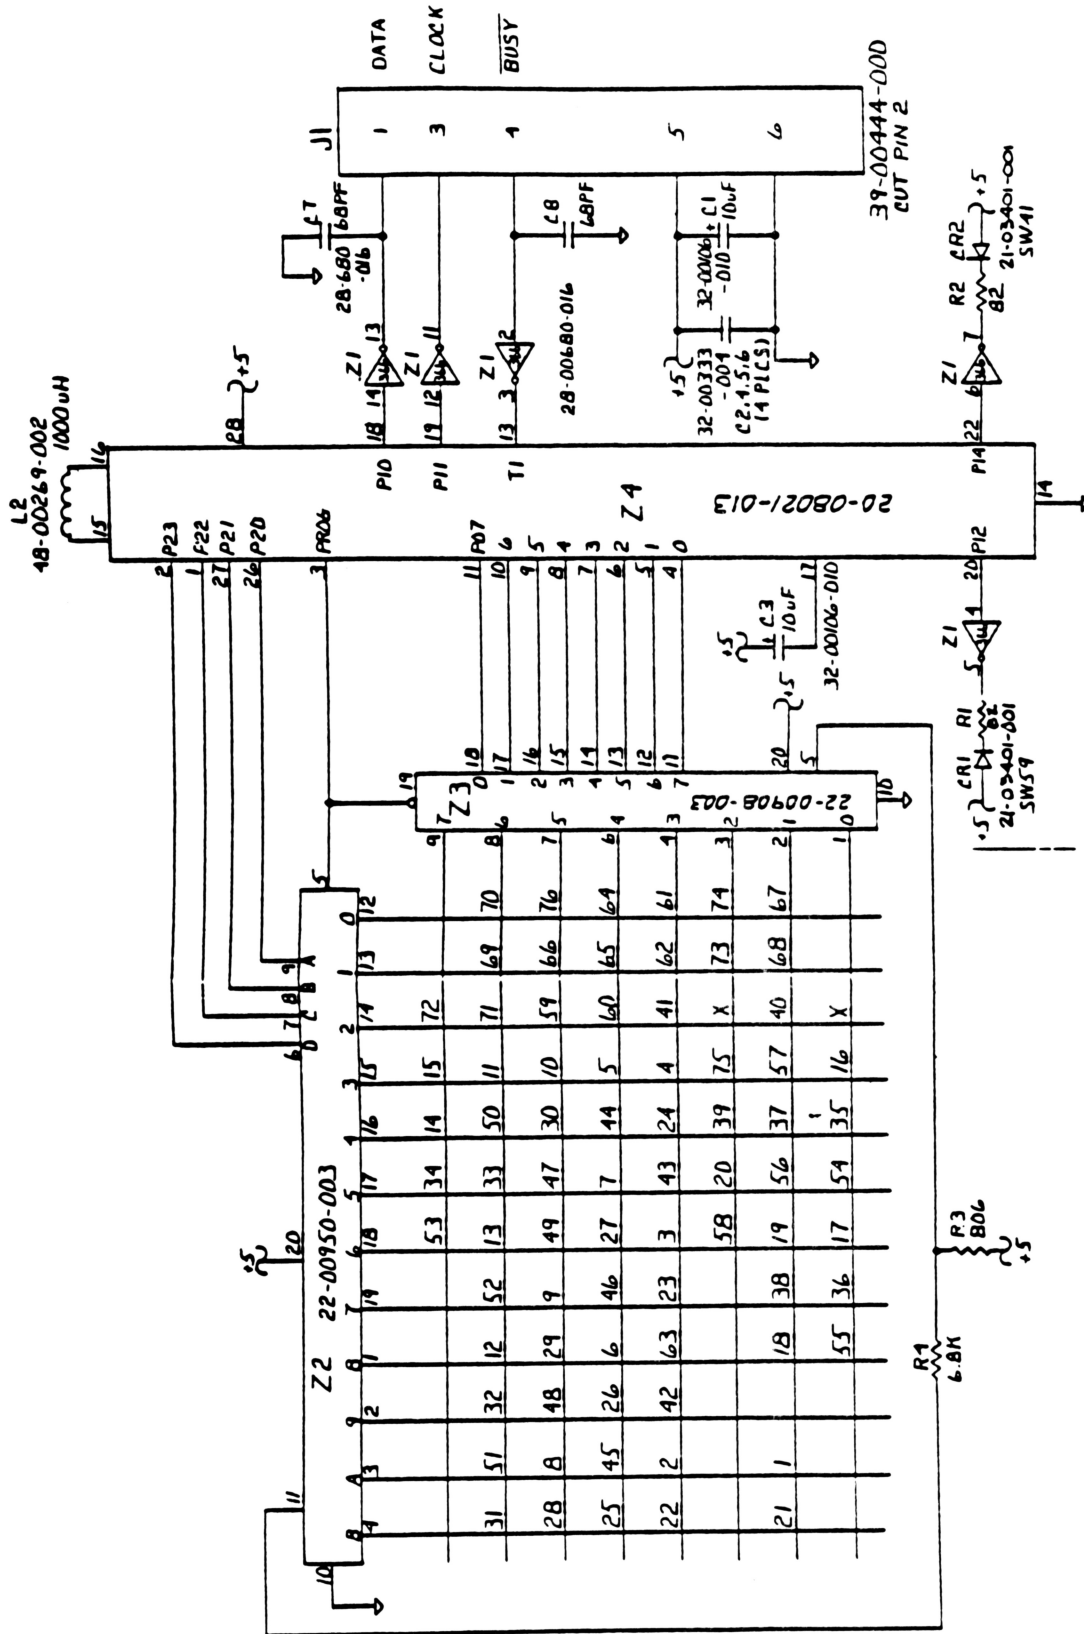
DISCUSSION: The Schematics for the Model II/16 keyboards in the Model II Technical Reference Manual are incorrect. Attached is the correct schematic and component location diagram.

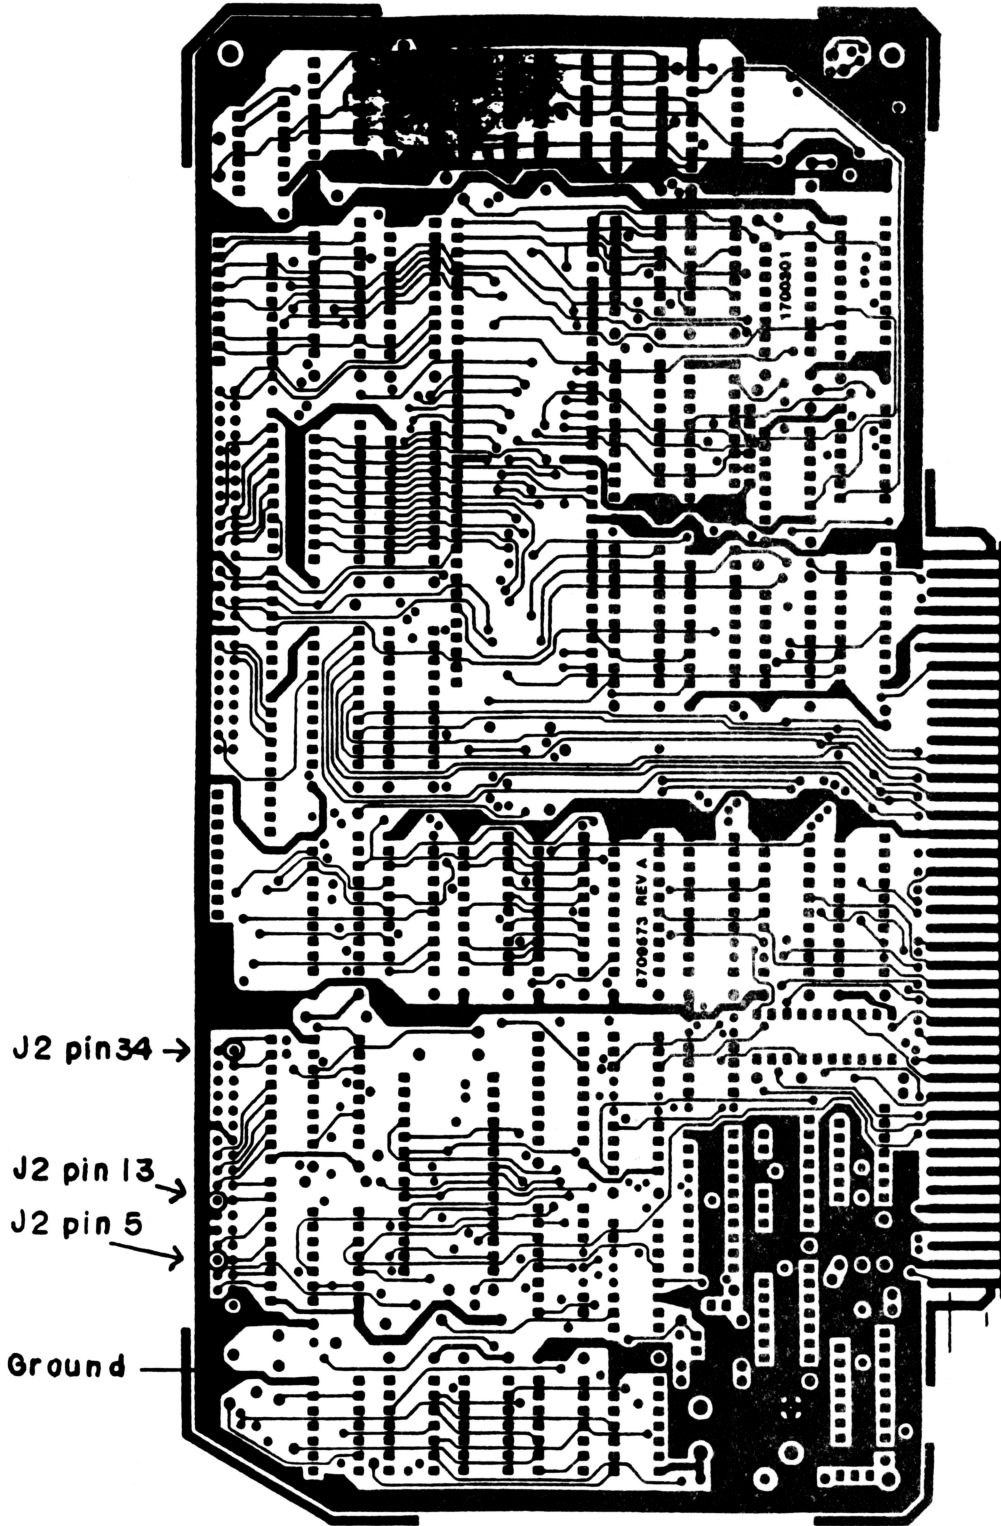
SOLDER SIDE (LAYER 4)

Due to an error in the artwork on early revision (Revision A) boards, a modification to insure good ground connections between the 68000 CPU board and associated memory boards is required.

Using wire wrap wire, install the following jumpers on the solder side of the 68000 CPU board:

- (1) Jumper J2, pin 5 to ground.
- (2) Jumper J2, pin 13 to ground.
- (3) Jumper J2, pin 34 to ground.

Ground may be found at the feed-throughs on the ground plane near J2 on the solder side on the board.

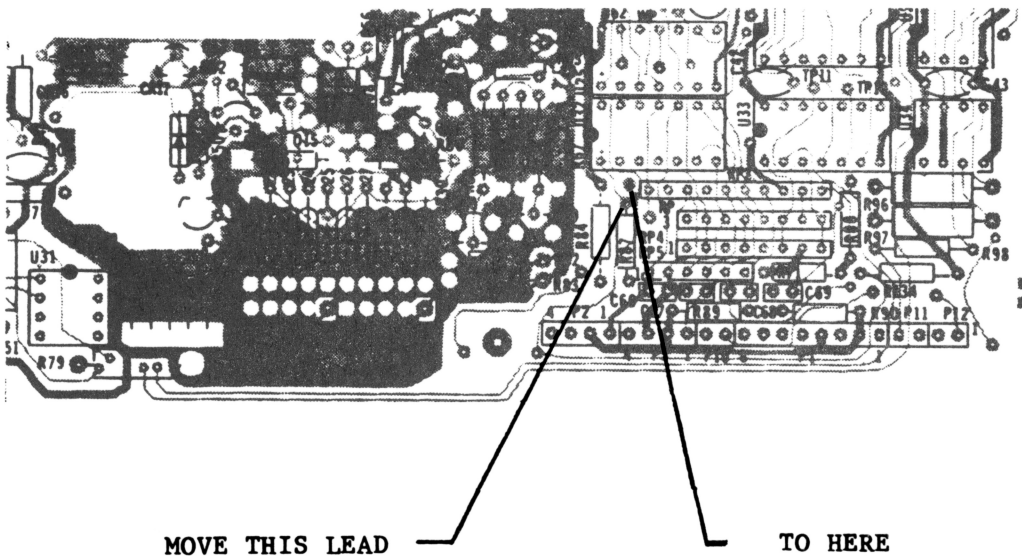
DISCUSSION: Some Tandon Belt Drive Logic Boards (Rev. Y) have come from the vendor with R87, a 150 ohm pullup resistor, installed incorrectly. These boards may be identified by the existence of a small white sticker (bearing a bar code, three numbers, and the letter "Y") attached to the board right next to the "REV" marking. The defective boards will not see the index pulses at all and will not recognize an inserted diskette, i.e. will remain at the "Insert Diskette" prompt even after a diskette is inserted and the drive door is closed.

PROCEDURE: Locate R87 on the Drive Logic Board. Note that one lead is connected to a feedthrough which has a trace running to U32, pin 1. Unsolder this lead of R87 and resolder it to the feedthrough right above it. The correct feedthrough is a +5V trace.
