TECHNICAL BULLETIN INDEX
Sorted by Bulletin Number
06/25/86

DATE: May 12, 1982
REVISION DATE: May 13, 1983
BULLETIN NO: 16:1
PRODUCT: 26-6001/2 Model 16
SUBASSEMBLY: AX-9241 FDC Board (Redesign)

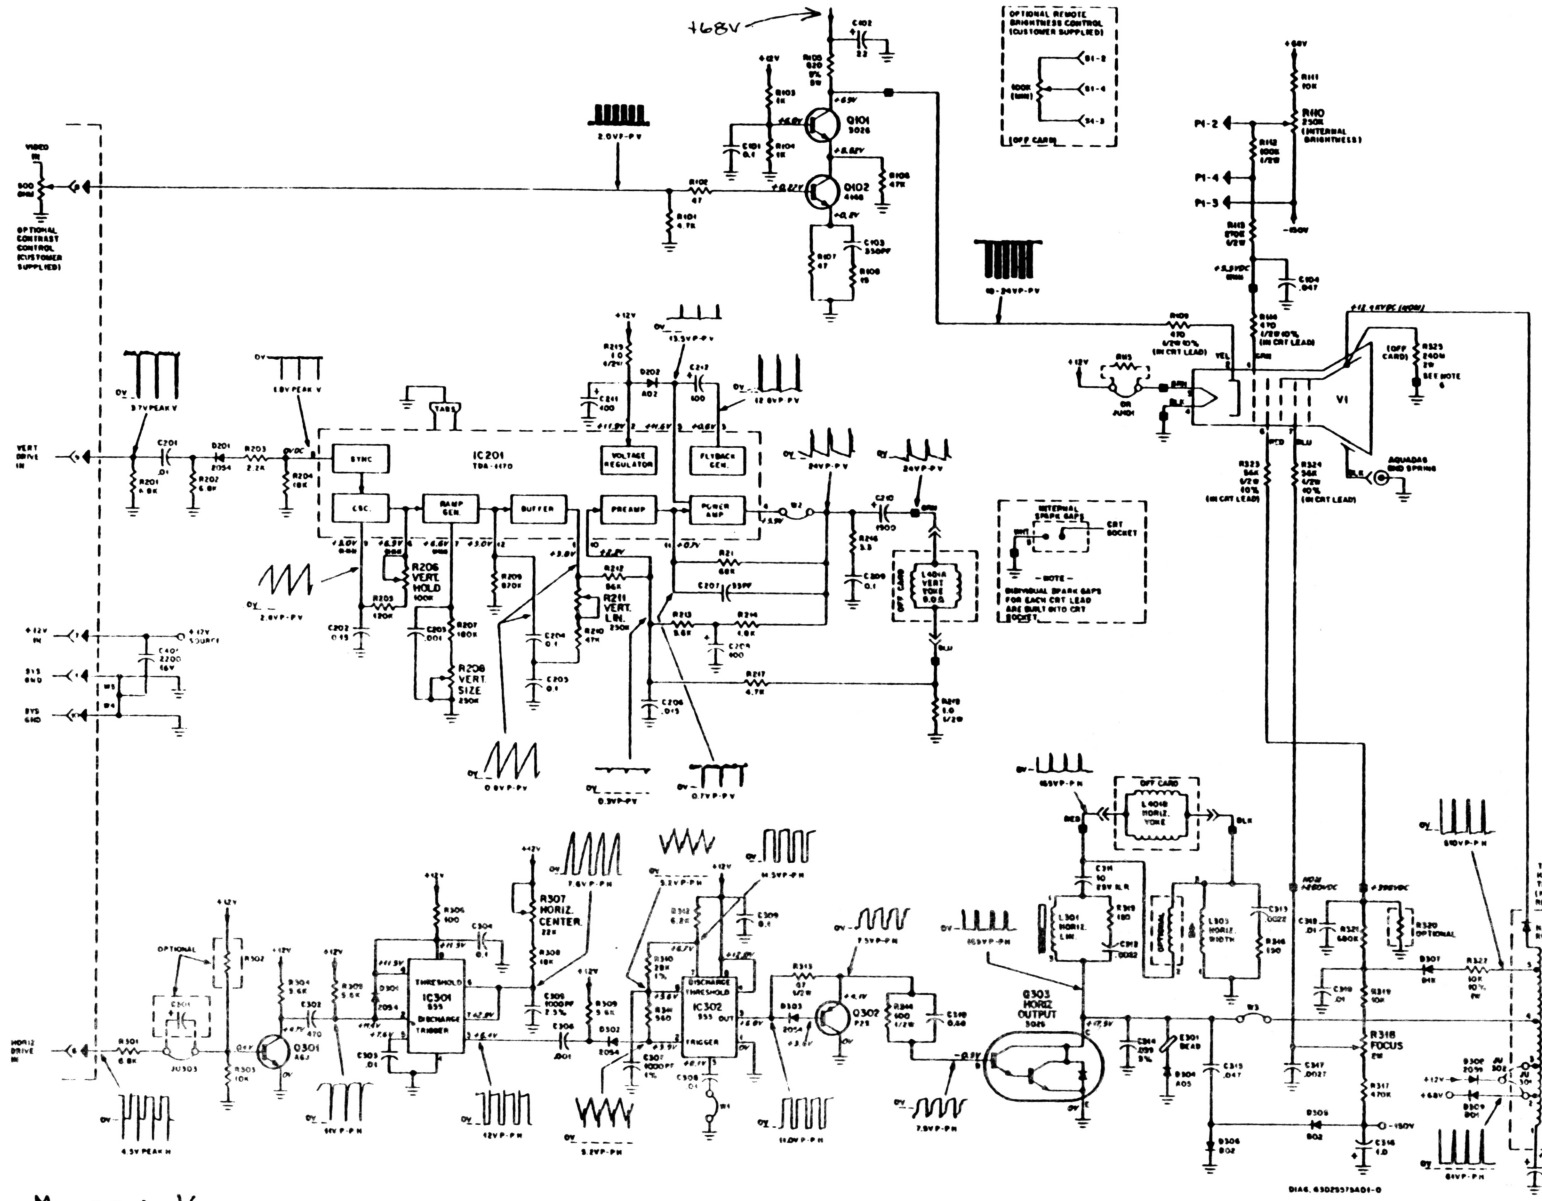
PROCEDURE: Attached are the schematic diagrams for the Motorola and Zenith Video Monitor boards found in the Model 16.

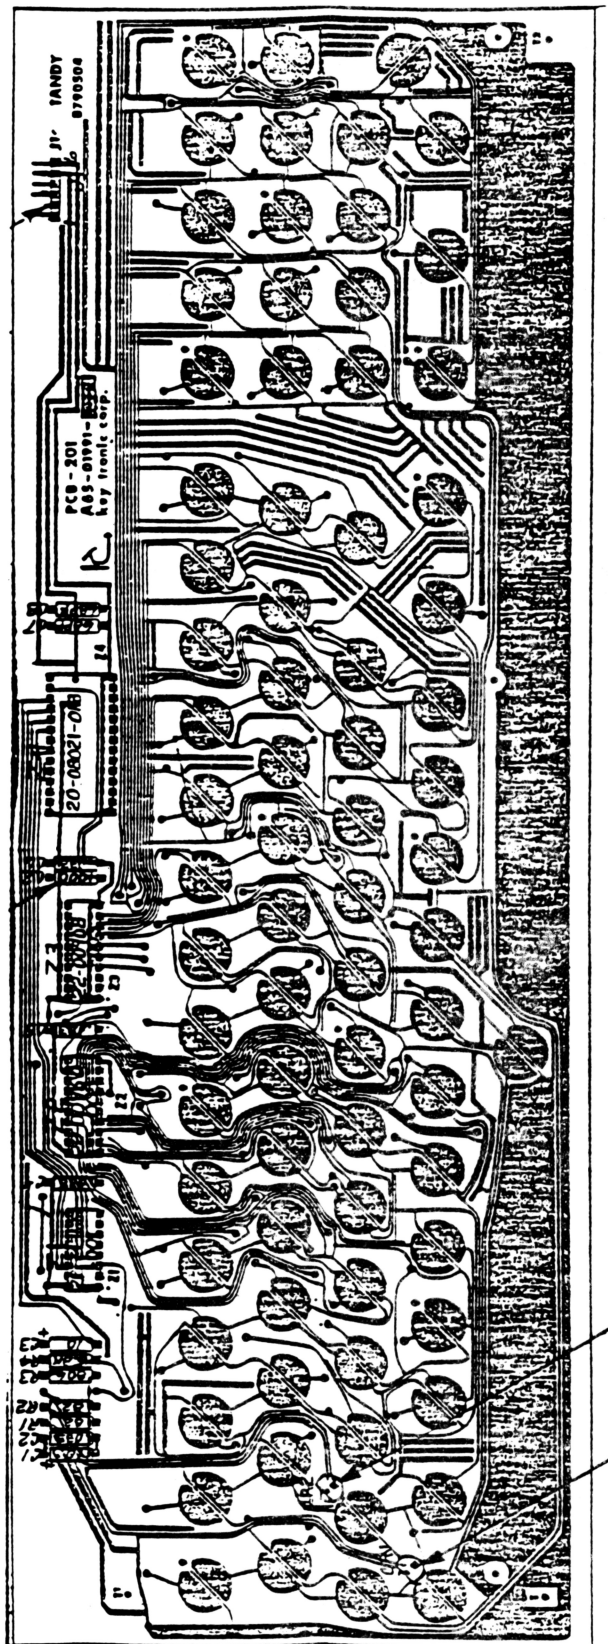
DISCUSSION: The Schematics for the Model II/16 keyboards in the Model II Technical Reference Manual are incorrect. Attached is the correct schematic and component location diagram.
